Naval Support Facility Indian Head (NSFIH) is submitting the Nationwide Permit (NWP) #27 annual monitoring report (Enclosure 1) for Corps Permit Tracking Number: CENAB-OPR-M (US NAVY/NSF INDIAN HEAD/WEST NOBLE ROAD) 2017-60335. This submittal meets the requirements of NWP #27 special condition #7. The survey work for the annual monitoring report was completed on October 25, 2018. The annual monitoring report also includes the quarterly and major storm event inspections that were required by the NWP #27 special condition #6.

**ANNUAL STREAM MONITORING REPORT FOR  
STREAM RESTORATION (BIAZZI) AT  
NAVAL SUPPORT FACILITY INDIAN HEAD, MD**

**Monitoring Year One-2018**

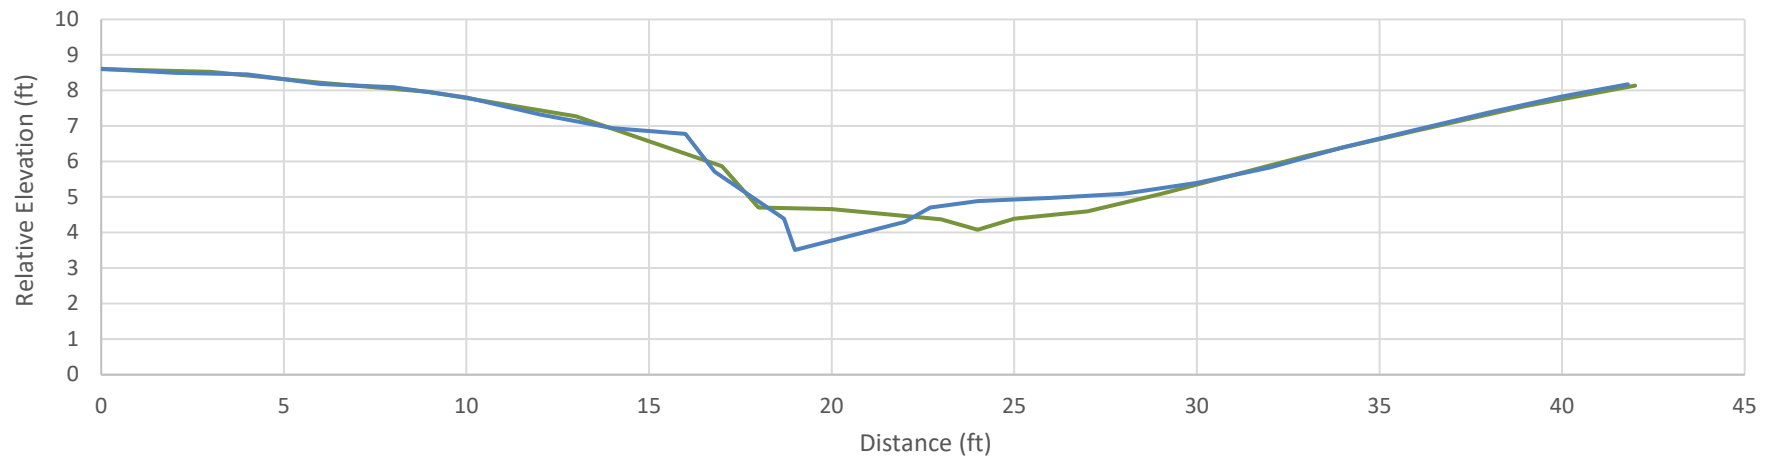
# Biazzi: Cross-Section 1 Sta. 1+34

Cross-section graphs and the stream profile graph are provided in **Appendix B**, and stream geomorphology results are summarized in Tables 2, 3, and 4. Overall, cross-sections changed minimally from those taken during the as-built survey and are classified as B channels, which are considered stable. Some adjustments in geometry have occurred, but are primarily attributed to settling of the stream, which is expected to occur during the first period of monitoring. Cross Section 1 (Sta. 1+34) has deepened approximately 0.5-feet and the thalweg has shifted to the left (facing downstream). Cross Section 2 (Sta. 0+74) has shifted minimally.

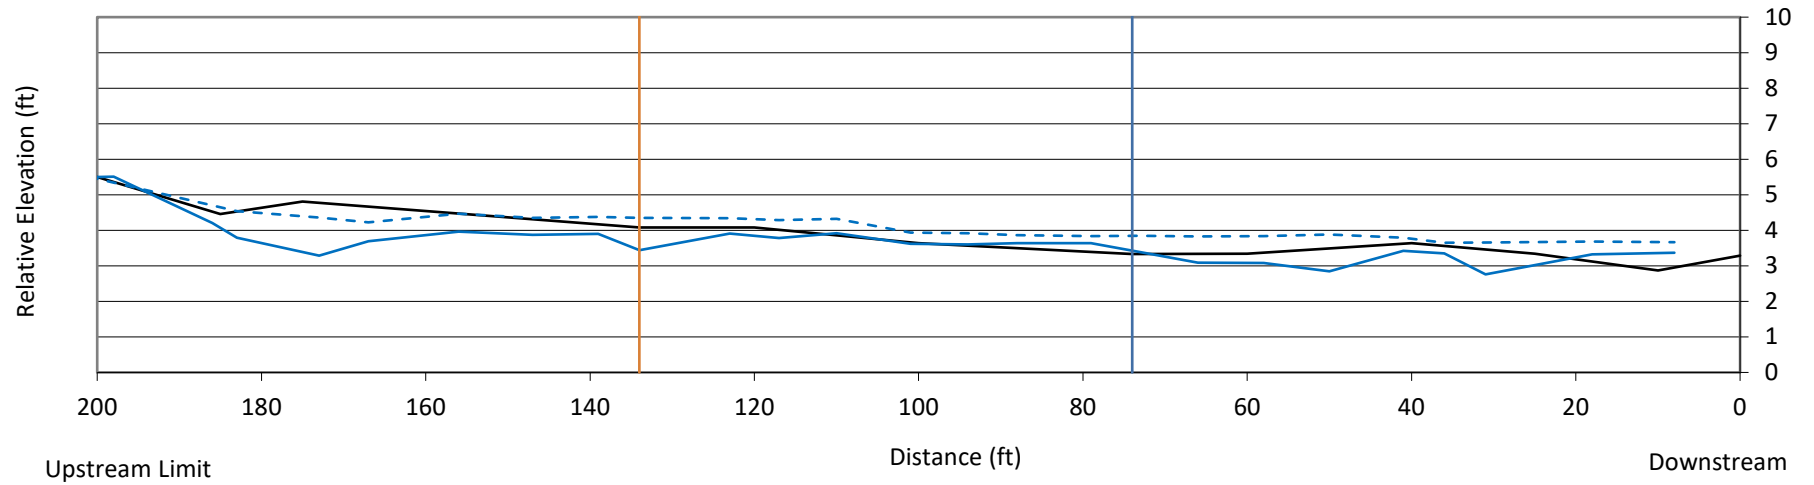
### Biazzi: Longitudinal Profile

The longitudinal profile taken during the as-built shows a slope of 0.0099 ft/ft compared to a slope of 0.0065 ft/ft during Year 1 monitoring. Changes to the longitudinal profile are more difficult to assess due to the coarse scale in which as-built data were collected, making bedform difficult to evaluate, however longitudinal profile appears to be stable based on cross sectional stability, stream classifications, and general site observations.

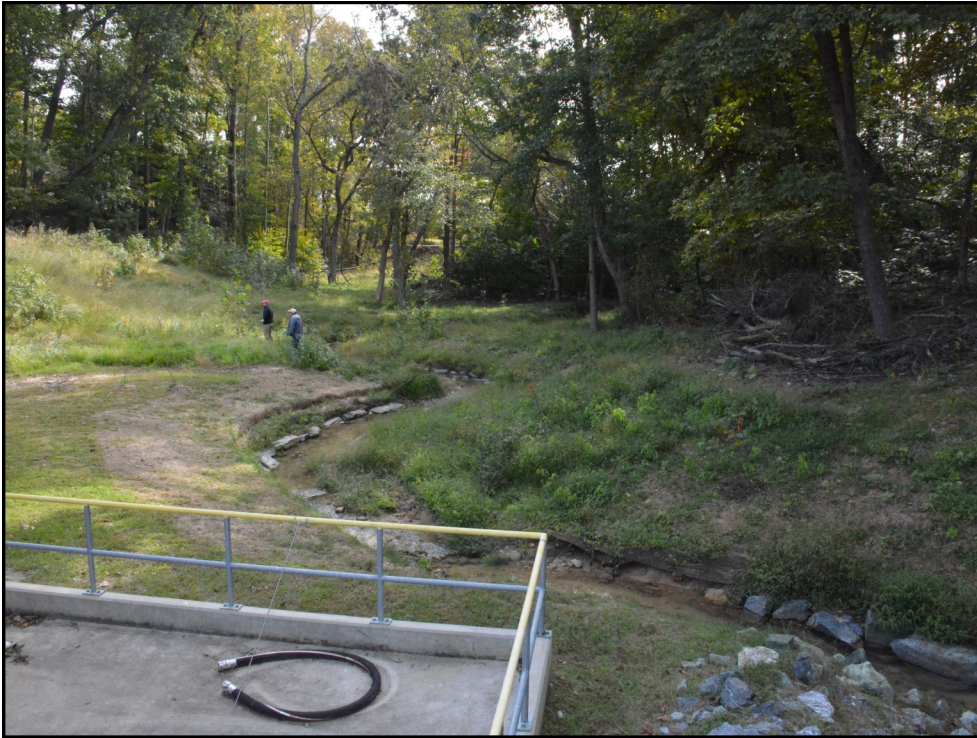
**Photo 1. Typical condition of site facing downstream.**

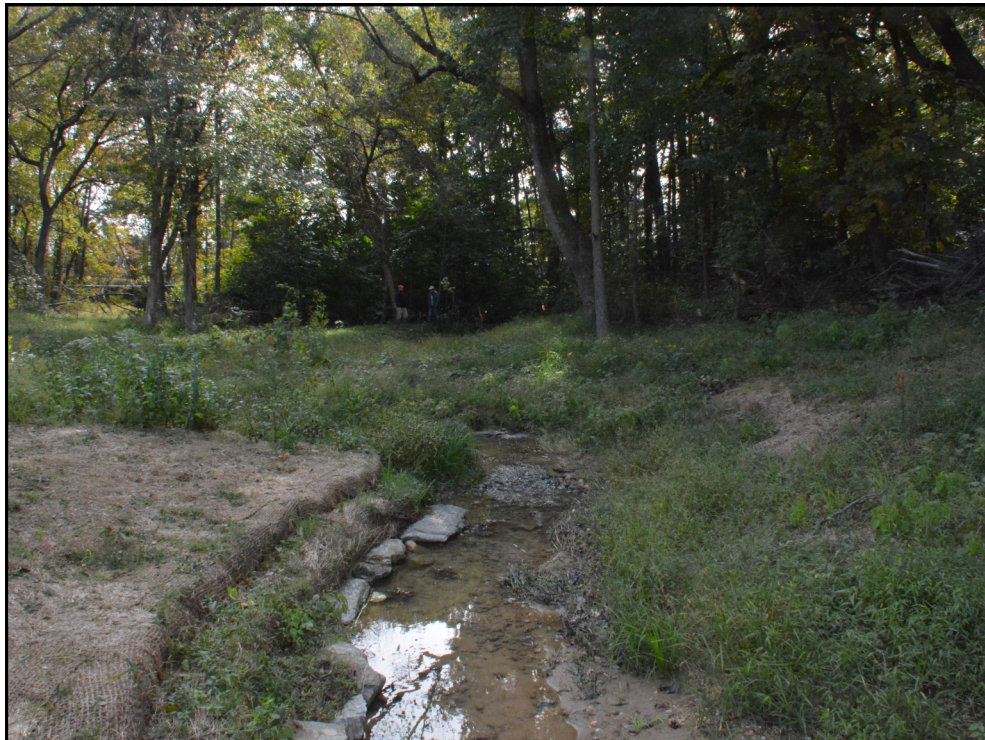
**Photo 2. Typical condition of site facing downstream from middle of site. Soil lifts, stone toe, grading, and vegetation are performing as designed.**

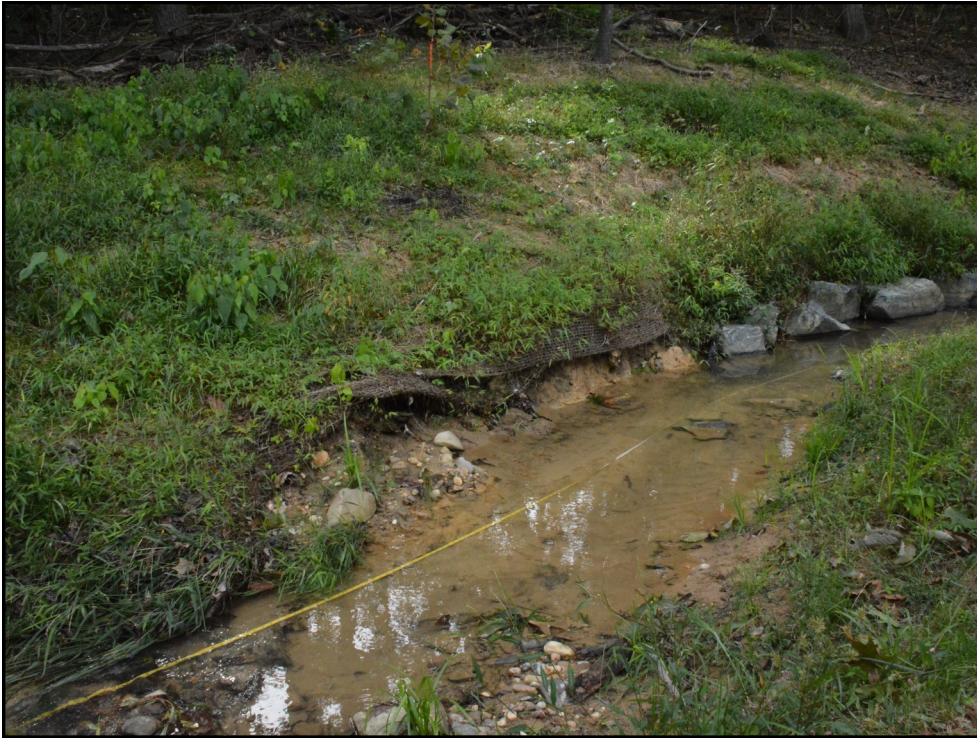
These inspections found that the channel depth had deepened approximately 0.5-1.2-feet in the vicinity of Cross Section 1. Approximately 12-feet of bank scour was also observed at the end of the stone toe installed along the right bank (facing downstream), directly downstream of the culvert's rip-rap outfall (**Appendix C**, Photo 3).

During annual monitoring, bank erosion was noted at the end of the stone toe installed downstream of the culvert. Approximately 12-linear feet of bank are exposed, which occurs along the terminus of a meander. Class II riprap on top of geotextile cloth was installed along this area to stabilize the bank.

**Photo 3. Ten to twelve feet of bank erosion at end of stone toe located along right bank (facing downstream) below culvert.**

With the exception of the 12-linear feet of bank erosion and deer damage, the site is performing as designed. The measures described above should be implemented to stabilize the eroding bank near Station 1+05, and plants should be back filled. Natural regeneration should also be considered as a viable option at this site due to the strong recruitment observed in Year 1. Vegetation survival will be reassessed in Year 2, and the quantity of volunteer species will be evaluated. If necessary, plants will be backfilled. Vertical stability will continue to be monitored via the longitudinal profile.

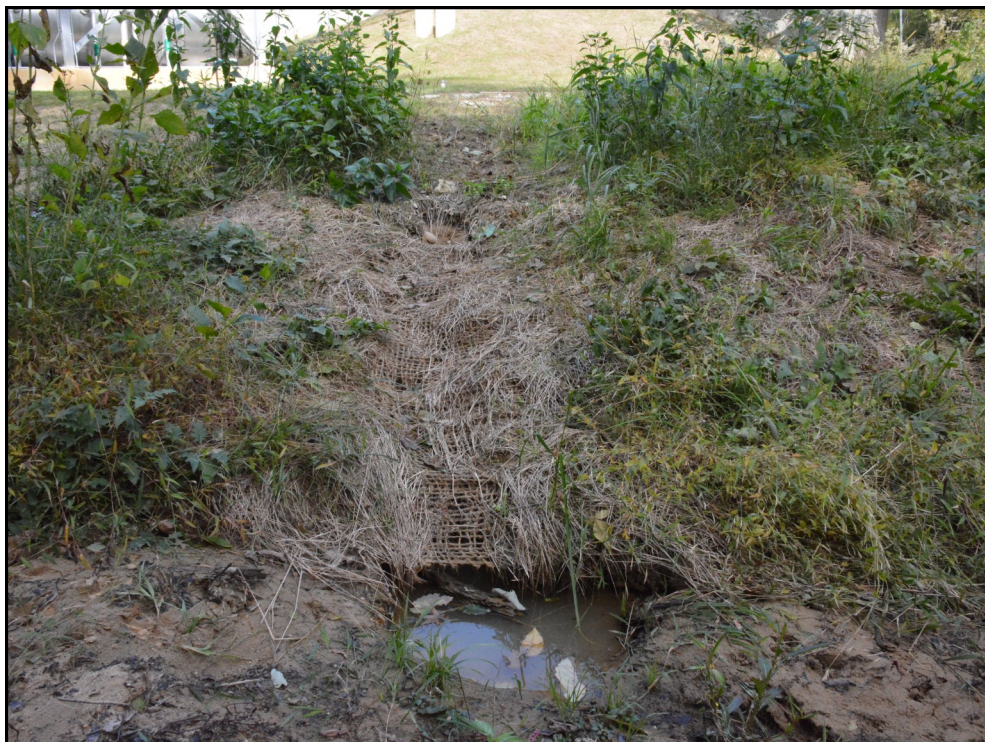
A head cut was observed downstream of Cross Section 2 (**Appendix C**, Photo 4). The headcut is forming from overland flow and has persisting saturated soils. Hydrology appears to be originating from an adjacent manhole and associated pipes, which have potentially failed.

The overland headcut downstream of Cross Section 2 is likely due to a failed pipe connection near the manhole located approximately 20 to 30-feet from the stream left bank, making soils persistently saturated. The Navy will repair the headcut downstream of Cross Section 2 through a project to make lighting and walkway repairs throughout the Biazzi Plant. The project will also address several drainage issues and this is one of the areas that will be repaired. The project is currently being designed with work anticipated to be completed by the end of 2019.

**Photo 4. Headcut forming under soil matting. Hydrology likely coming from adjacent manhole and associated pipes.**

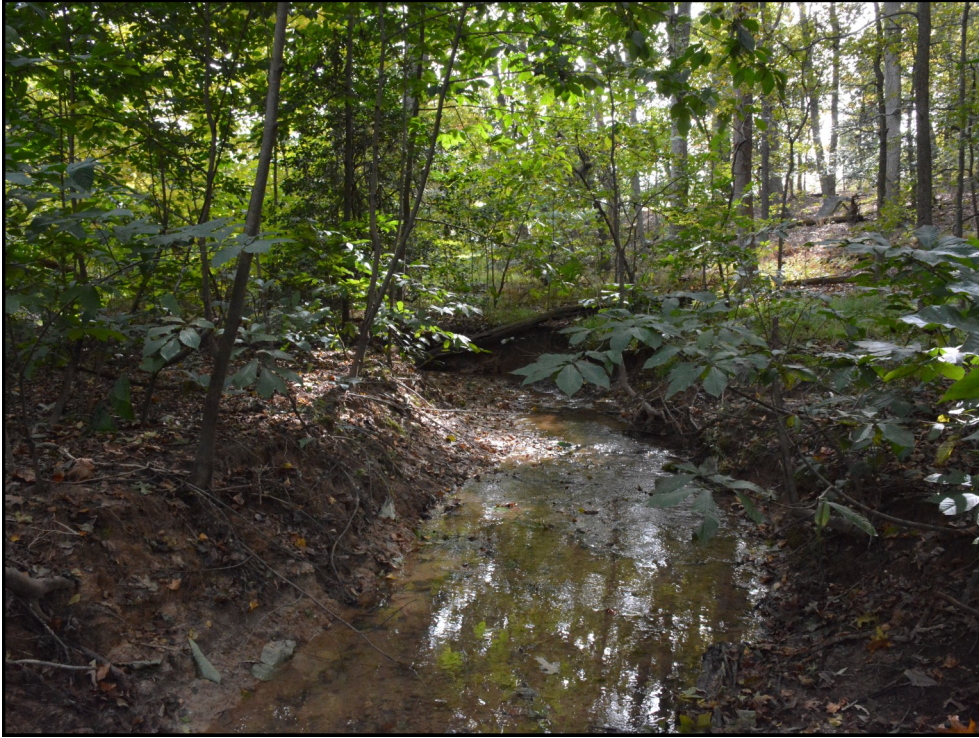
**Photo 5. Visual inspection of wetlands and floodplain located within 200-linear feet of project limit. No excess sediment deposition observed.**

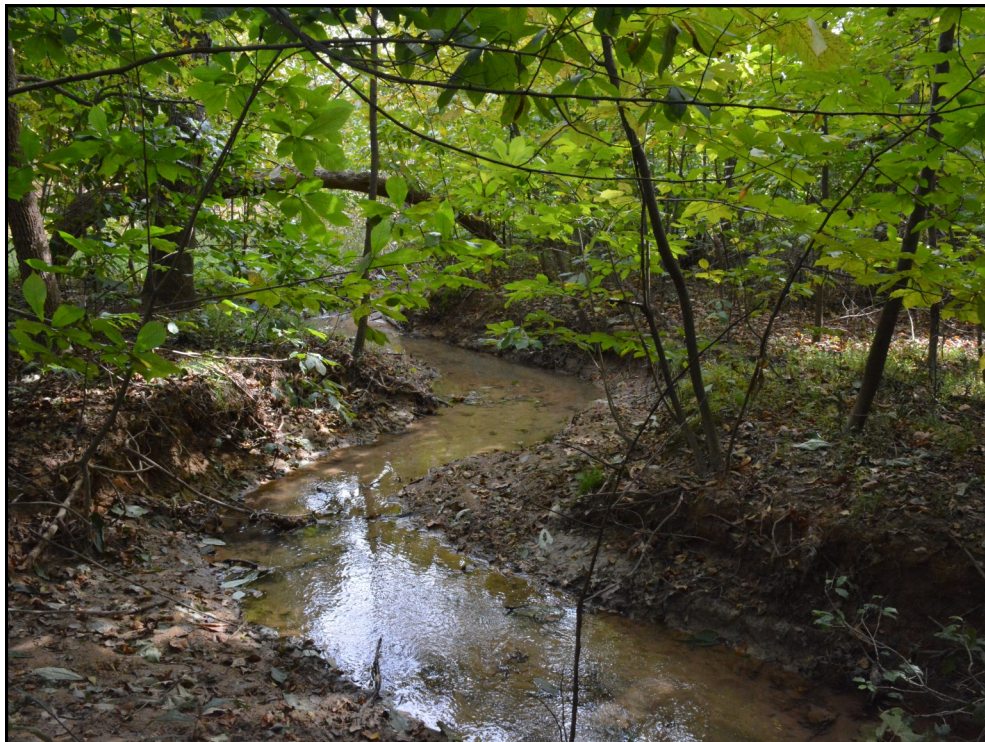
**Photo 6. Visual inspection of wetlands and floodplain located within 200-linear feet of project limit. No excess sediment deposition observed.**

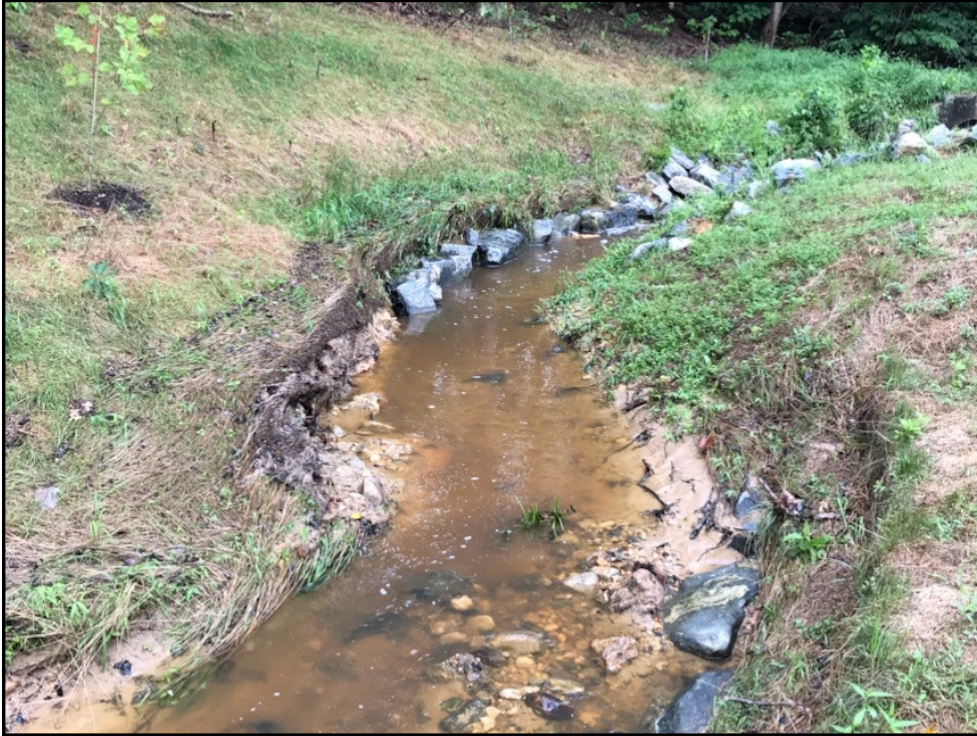
**Photo 9. Post-storm inspection on 7/23/2018 following 5.41-inch storm (facing upstream). Slight bank scour at end of stone toe.**

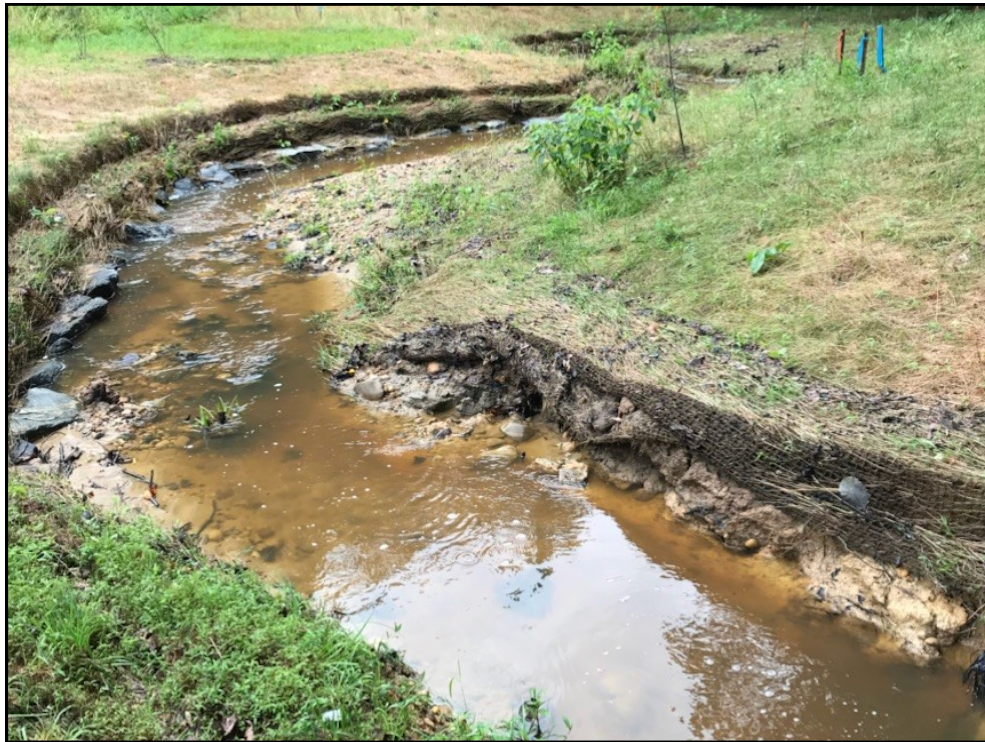
**Photo 10. Post-storm inspection following 5.41-inch storm (facing downstream). Slight bank scour at end of stone toe.**
